Arizona-Southern California Outages on September 8, 2011

Causes and Recommendations

Prepared by the Staffs of the
Federal Energy Regulatory Commission
and the
North American Electric Reliability Corporation

April 2012

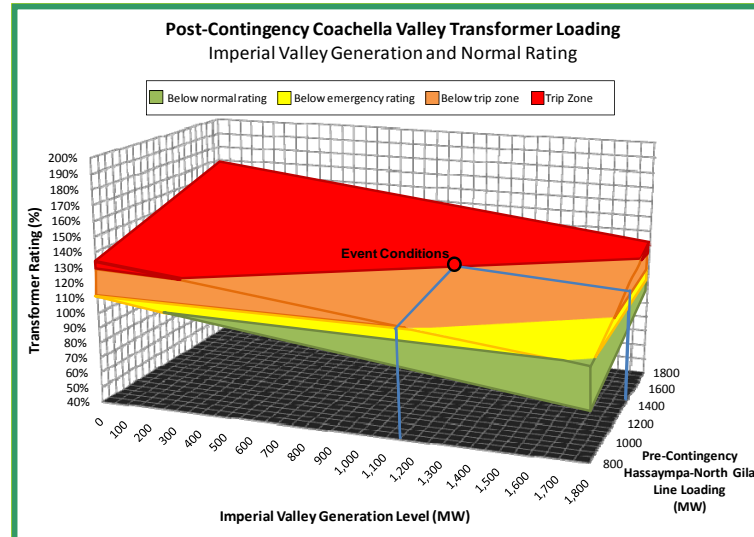
Figure 7 : Post-Contingency CV Transformer Loading Based on Imperial Valley Generation

In general, adding generation in San Diego, CFE, or Imperial Valley and backing down generation in APS's system (east of Path 49) would reduce the loading on IID's 92 kV system for the loss of H-NG. For example, an additional 600 MW of generation at Imperial Valley and a reduction of generation in APS's system by the same amount would have reduced the pre-contingency loading on H-NG by 20% and improved the post-contingency voltage in WALC's Blythe area by approximately 4%. Under this condition, the loading on the CV transformers for the loss of H-NG would be approximately 111% of their normal rating (166 MVA), well below their trip setting of 127%. This is a further demonstration of the importance of including all facilities when deriving SOLs.

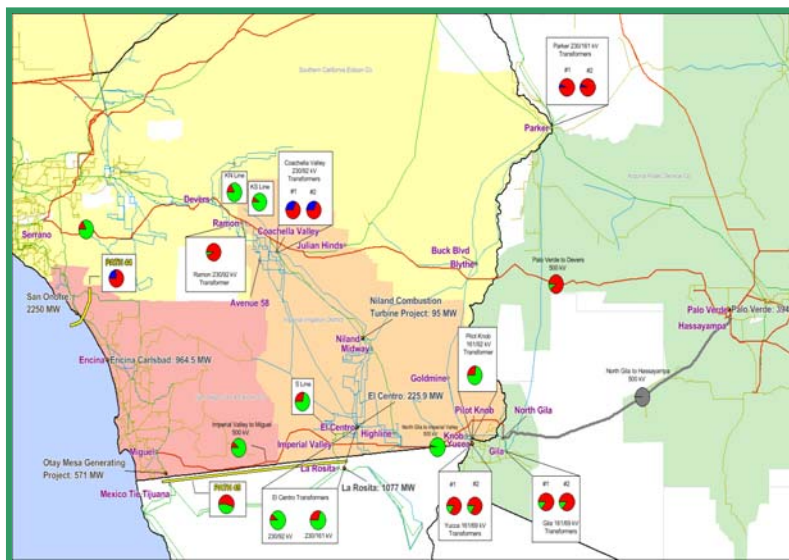
15:27:39 – The Hassayampa- North Gila 500 kV line tripped.

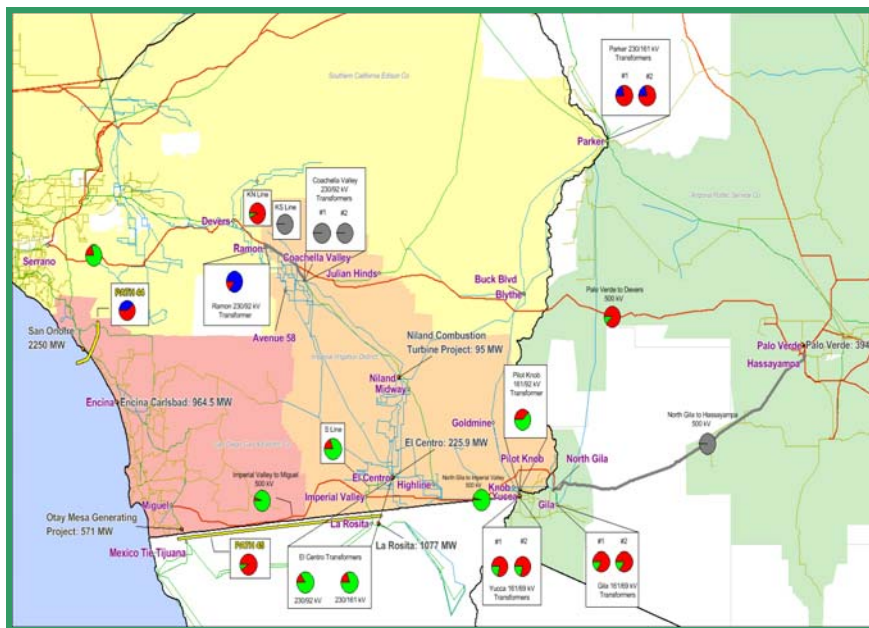
15:28:17 – Two Coachella Valley 230/92 kV transformers and the Coachella Valley Ramon 230 kV “KS” line tripped. (030)

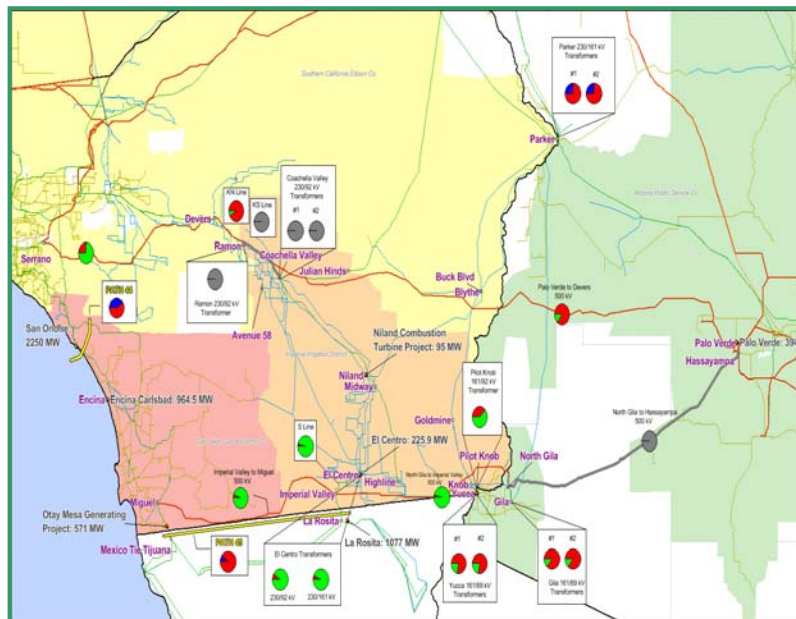
Time: 15:32:10 – The Ramon 230/92 kV transformer tripped and IID shed 444 MW of load. (110)

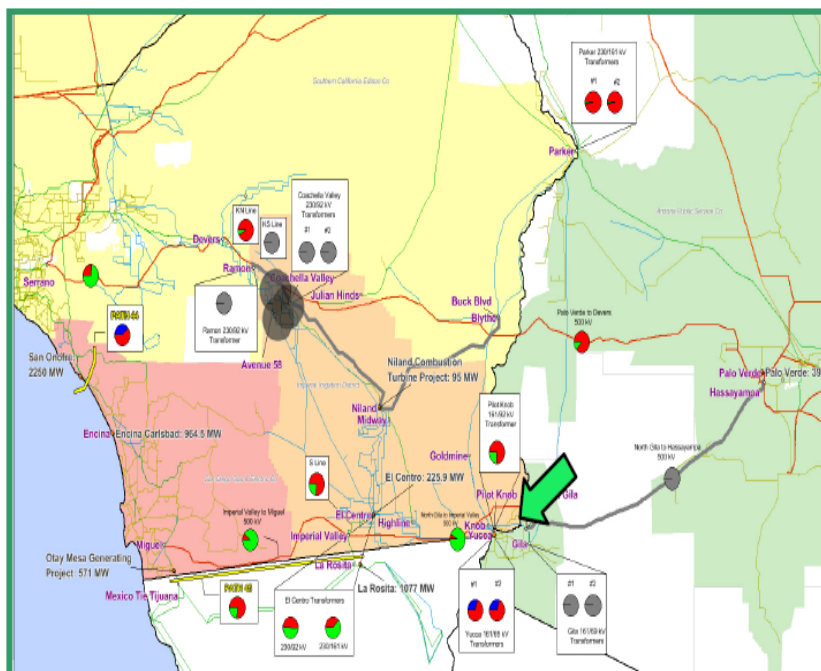
Time: 15:35:31 – Yuma Cogen (YCA) tripped. (180)

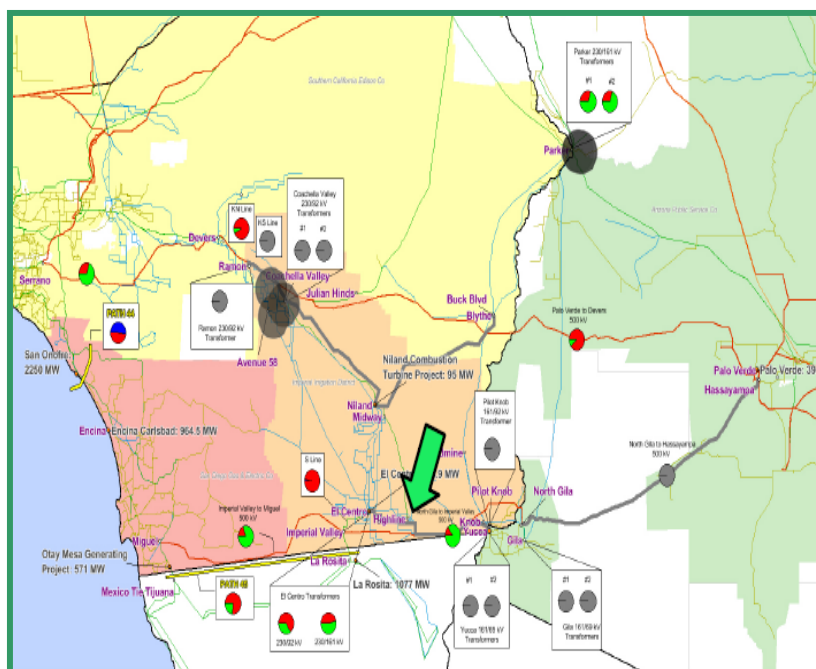
Time: 15:37:55 – The El Centro-Pilot Knob 161 kV line tripped. (230)

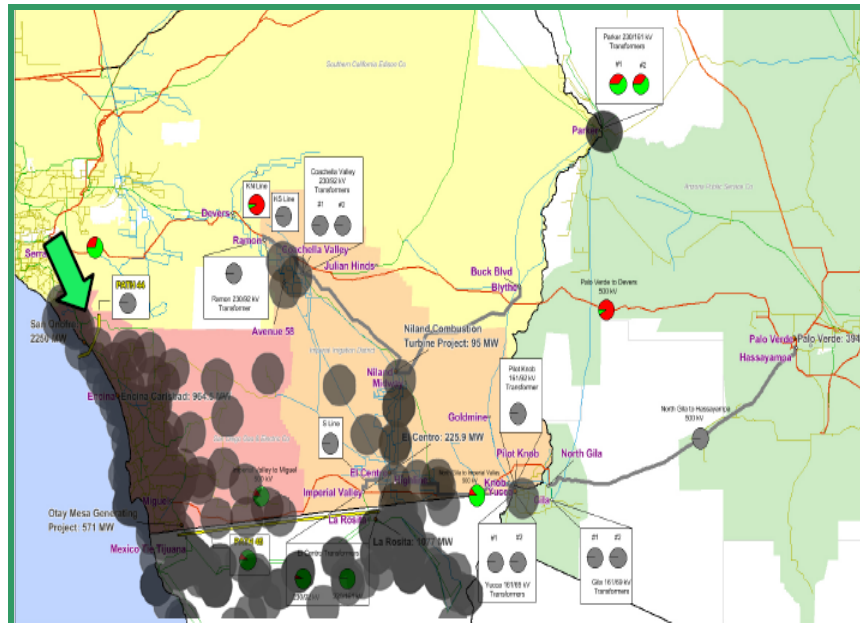
Time: 15:38:30 – The South of SONGS Separation Scheme operates and both SONGS units tripped. (300)

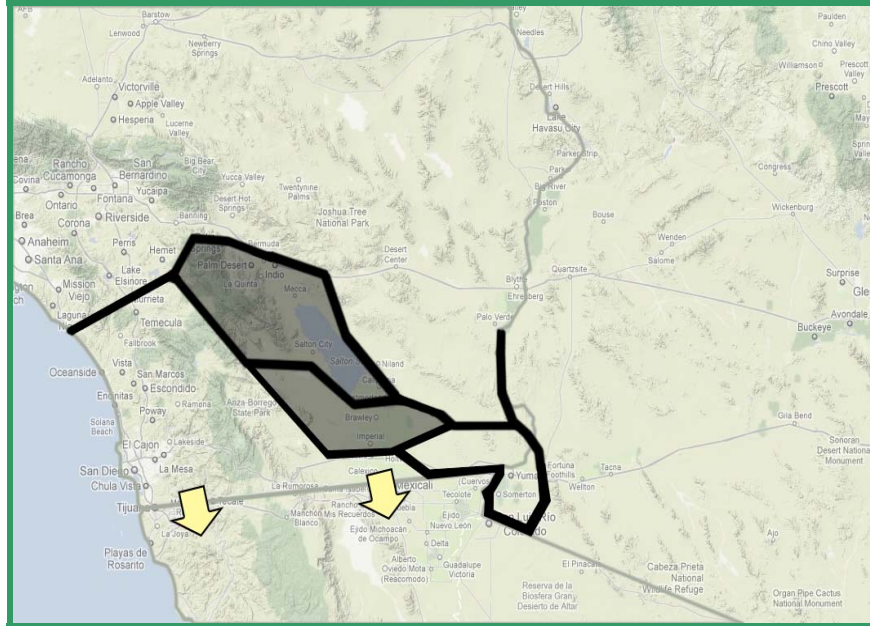
The Yuma island separated from SDG&E at 15:38:23.12, when the Imperial Valley-North Gila 500 kV transmission line tripped by underfrequency protection. APS's UFLS operated on 26 out of the 28 feeders in the Yuma area prior to the loss of the local Yucca steam generators that were on line. However, there was insufficient local generation to stabilize the load pocket in Yuma. At 15:38:38, the Yuma island internal units tripped on underfrequency protection.

Yuma Separates (Time: 15.38.23.12)

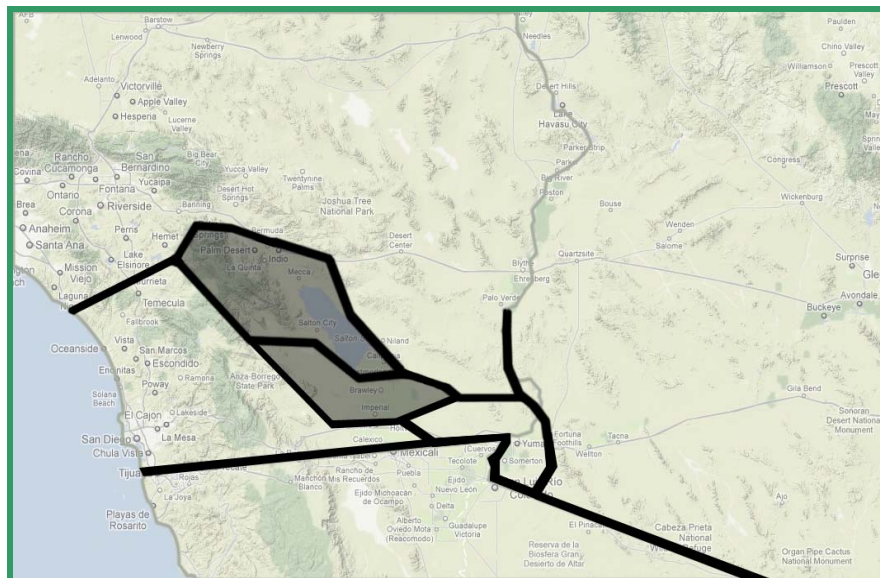
The CFE island separated from SDG&E after their only two remaining ties tripped in rapid succession. At 15:38:22.2, the Otay Mesa-Tijuana 230 kV transmission line open-ended at Tijuana in CFE's territory due to underfrequency protection.⁵⁵ Less than a second later, at 15:38:23.13, the Imperial Valley-La Rosita 230 kV transmission line open-ended at Imperial Valley in SDG&E's territory by underfrequency protection.⁵⁶ According to CFE, its UFLS program was not designed for the operation of a SDG&E/CFE/Yuma island, but for the operation of a "southern WECC island."

CFE Separates (Time: 15.38.23.13)

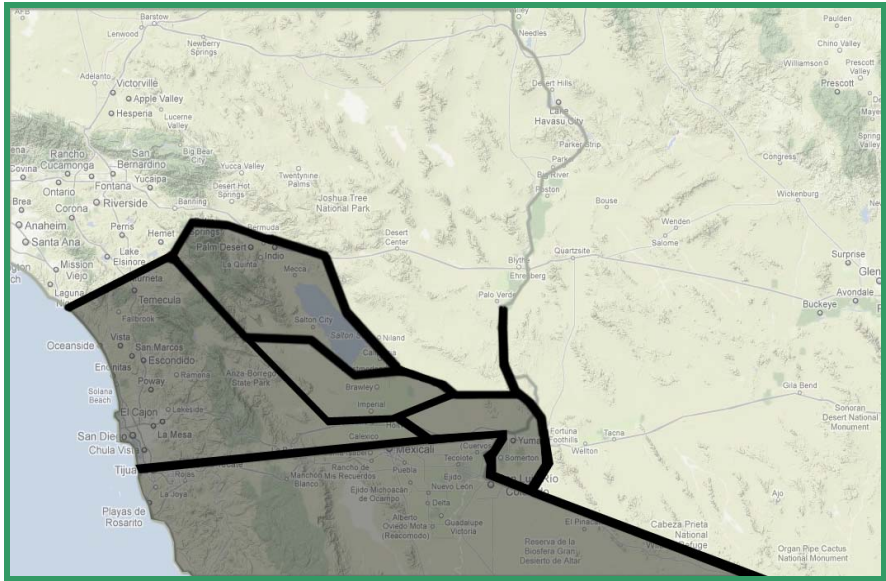
By 15:38:38, the SDG&E, CFE and Yuma islands had all collapsed, leaving approximately 2.7 million customers without power.

SDG&E, CFE, and Yuma Blackout (by 15.38.30)

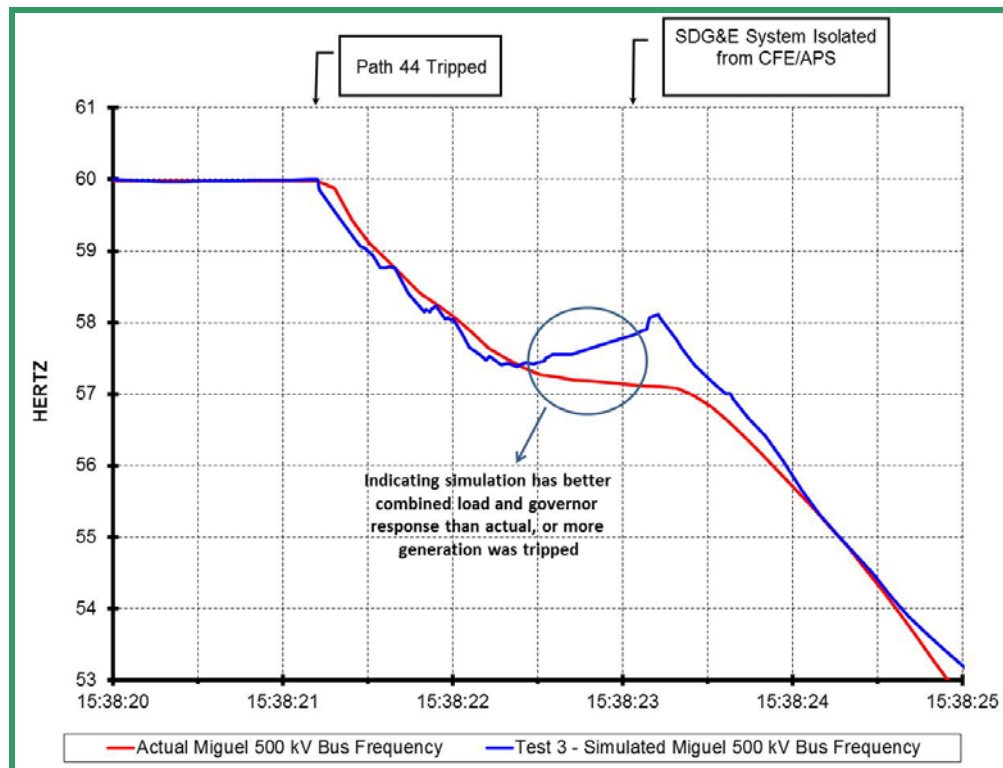
Figure 15: Miguel Frequency Actual and Simulated for "Test 3"

The simulation studies explain the ineffectiveness of the UFLS program, despite up to 75% of SDG&E load that was shed within 1.3 seconds of the SONGS separation scheme operating. The simulation analysis confirmed findings in the inquiry's SOE that the frequency collapse was caused by generation trips and UFLS misoperations within CFE shortly after Path 44's separation, followed by additional generation trips within SDG&E around the time it separated from CFE/APS.

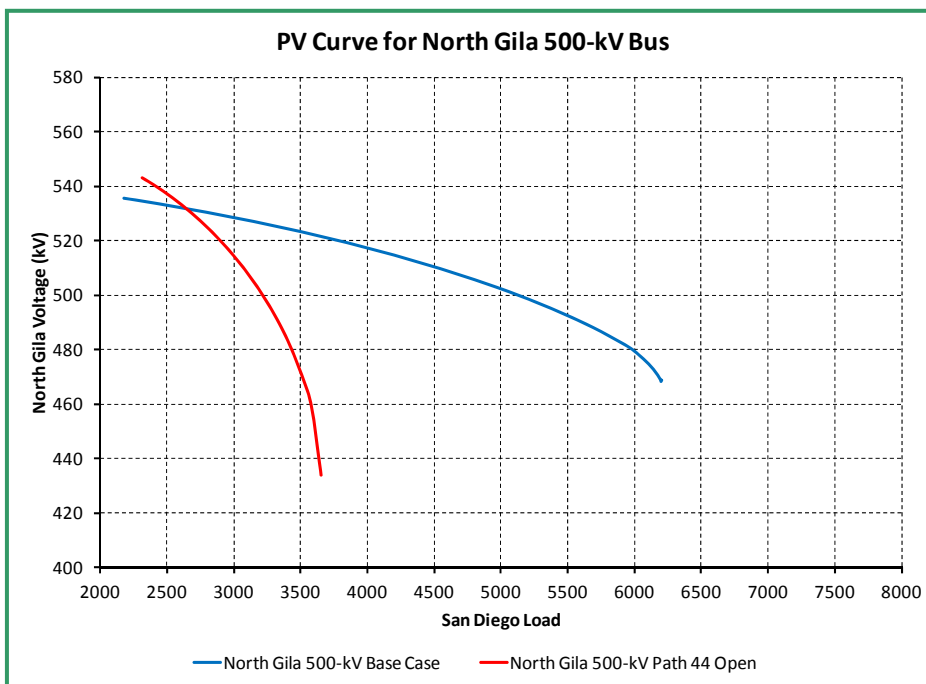
Figure 16: PV Curve for North Gila 500 kV Bus

Specifically, the system is most likely to collapse when the SDG&E load exceeds 3,500 MW. In 2010, SDG&E's load exceeded this amount for 851 hours,⁹⁷ meaning that

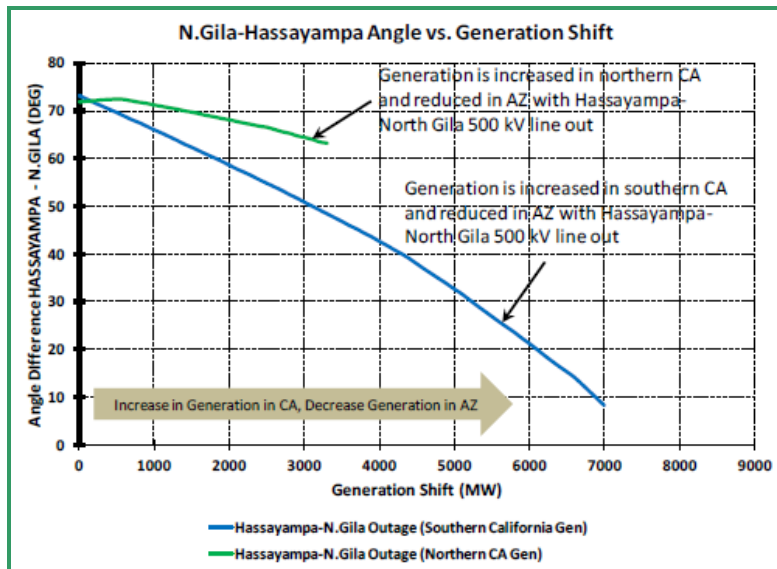
Figure 17: Phase Angle of H-NG vs. Generation Shift

The blue line in Figure 17 illustrates that with the particular conditions of the September 8th event, approximately 1,800 MW needed to be redispatched on both ends of H-NG (and close to the terminals, in Southern California and Arizona) in order to close the voltage phase angle from 72 degrees to 60 degrees (i.e., to within the permissive 60 degree setting of the synchro-check relay). The green line shows that more generation—more than twice as much—must be redispatched if units are chosen in Northern California to close the angle between Hassayampa and North Gila.

While system operators could redispatch generation from available spinning reserves or commit units in the Southern and/or Northern California area, it is questionable how quickly 1,800 MW could be dispatched.
